D2.5 / Summary of the deliverable: “Measurements of wall pressure and material loss for different fluids and target materials “

provided by ESR 6, Ms Iris Koukouvini under the guidance of Dr Ioannis Karathanassis and Prof Manolis Gavaises, CITY, University of London, November 2018

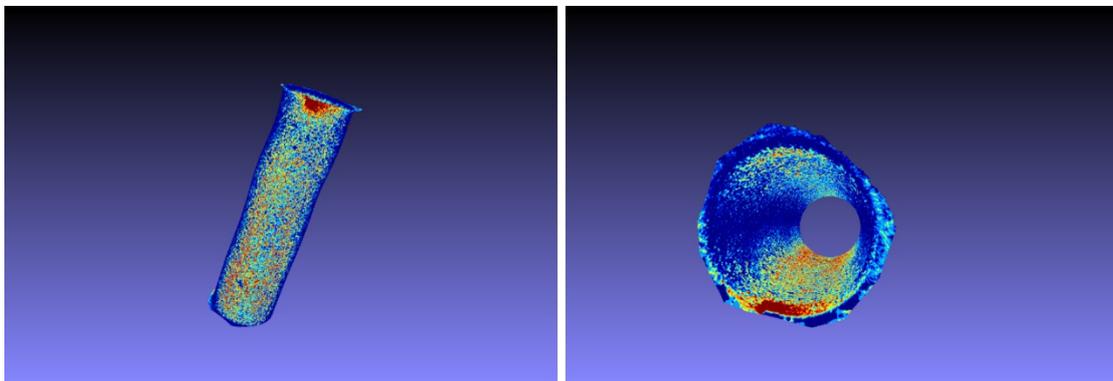
Figure: Alteration at the orifice wall surface after 24 hours exposure to cavitating flow at CN~6, Re=35500. (Left panel) Bottom view. Flow is from top to bottom. (Right Panel) Cross-sectional view with orifice entrance being at the foreground. (Range 6 (blue)-24 (red) μm).

Finally, on the second part covering the erosion test, a closed hydraulic circuit similar to that used for the shadowgraphy setup, was employed. At time intervals of 4 hours and up to 24 hours, each model under investigation was scanned using the Micro X-ray Tomography facility at the University of Bergamo, to extract the geometrical changes caused by cavitation-induced erosion. Through the acquired results, the 3D reconstruction of the geometries was computed based on logarithmization and filtered back projection.

Consequently, the geometrical change of the orifice surface structure due to the erosion was captured and was properly quantified, compared to a reference scan of orifice prior to being exposed to cavitating flow.
