### Summary of the deliverable D4.3: Model application to ship hull – propeller flow

provided by ESR 12, Mr. Themistoklis Melissaris, under the guidance of Dr. Norbert Bulten, Wärtsilä Netherlands BV, and Prof. Tom van Terwisga, Delft University of Technology, September 2018

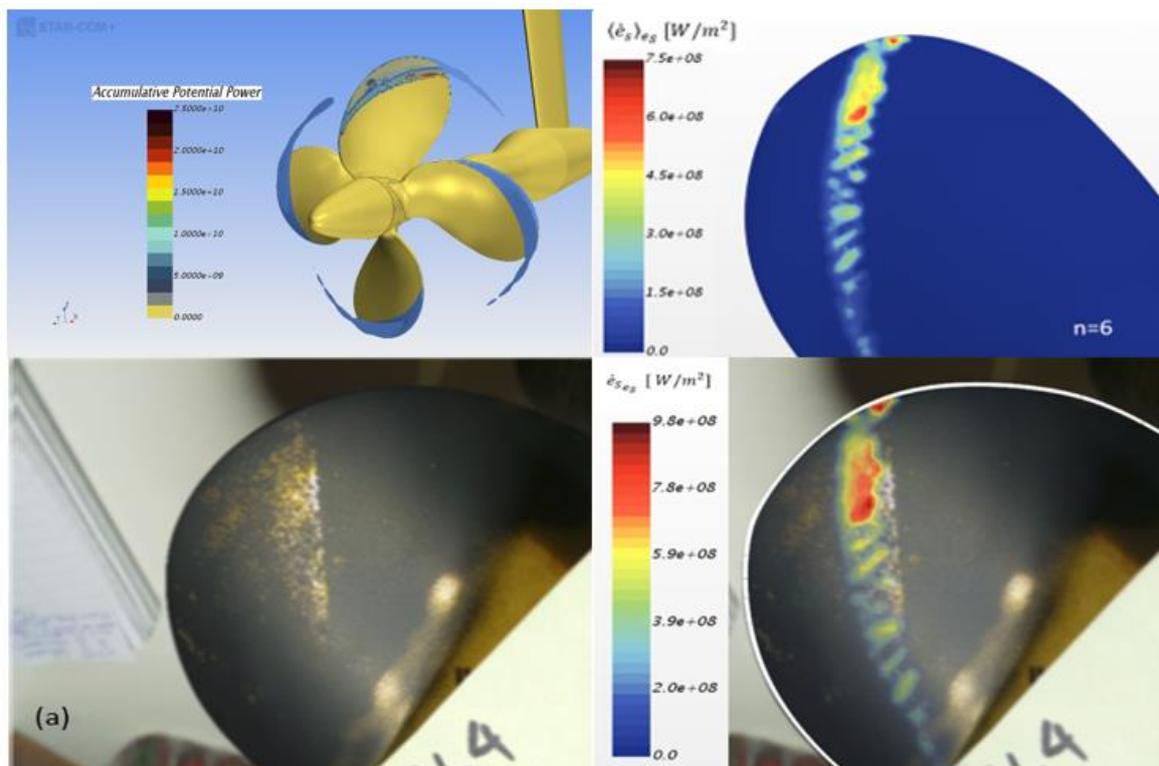
Figure. 1 Cavitation development and erosion risk assessment on the KCD-193 model propeller. The accumulative potential power on the blade (top left), the aggressiveness indication on the blade (top right), the erosion pattern obtained from the paint test (bottom left), and the comparison of the CFD solution with the indicated damage areas (bottom right) are shown.

In the present work, it is hypothesized that the vapor structures, which are in contact with the surface, are much more aggressive than any other structure, no matter how close they are to the wall. Thus, we assume that the direct impact on the surface face from the structures touching the surface, is much higher than the one from any other structure away from the surface. Therefore, it is not required to calculate the distance and the projection of any vapor structure, giving us an erosion risk assessment with no additional computational cost. A verification and validation study are conducted on the Delft Twist 11 hydrofoil, followed by an estimate of the cavitation impact distribution on the surface. The effect of the pressure field driving the collapse on the distribution of the initial potential energy to the surface is identified and two erosion risk indicators are used to assess the flow aggressiveness. It is further hypothesized, that the investigation of the erosion risk on the propeller blades in behind condition, does not require the use of the ship hull. An inlet boundary condition, that describes the inflow to the propeller in a similar way as if it operates behind the hull, is considered as sufficient. Thus, the same model is applied on the KCD-193 model propeller operating behind a wakefield. In both test cases, the impact distributions show a good agreement with the damage patterns obtained from paint tests, when we account for the effect of spatial pressure recovery, as the driving pressure, by time averaging the local pressure field. High erosion risk is found in all regions identified by the experiments.
